# TCG 01-G & TCG 02-G Firmware Release Notes

VERSION F2.28r3 (November 2017)

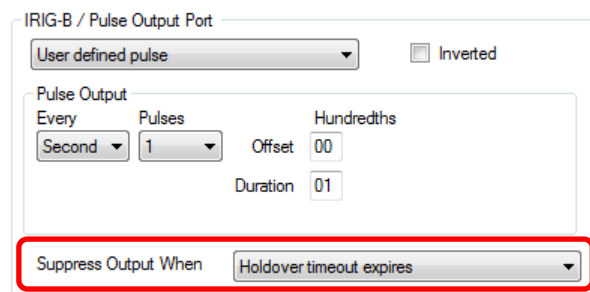
Added the ability to independently suppress individual outputs based on inaccuracy threshold or holdover timeout. When “holdover timeout expires” is selected, that particular output will stop providing a time signal when the clock is out of sync and the specified holdover time has expired.

This applies to the following ports:

- Configurable IRIG-B / Pulse output ports (P2, P3, P4 pin 1)
- P4 serial string output port
- P5 AM IRIG-B output port
- P11 configurable IRIG-B / Pulse output port (TCG 02-G M2 expansion)
- P9 configurable IRIG-B / Pulse output port (TCG 02-G M3 expansion)
