## NTS 02-G & NTS 03-G+ Firmware Release Notes

VERSION 3.21r3 (November 2017)

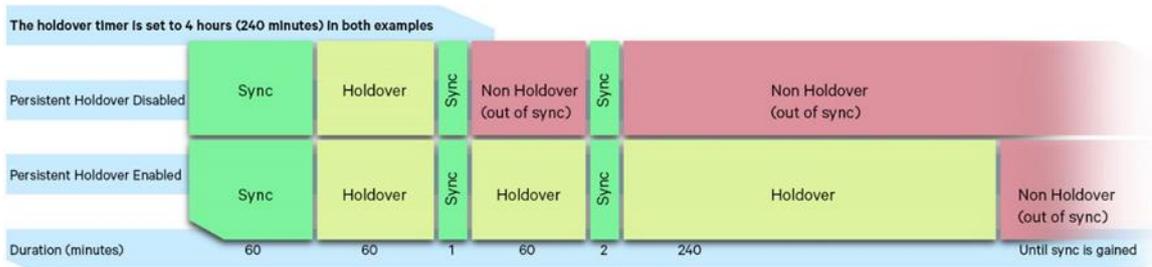
Normally, the clock can only enter holdover if it has been in sync for at least 5 minutes. If persistent holdover is enabled, and the clock has initially been in sync for at least 5 minutes, then the clock can still enter holdover if it experiences a sync switching condition. For example, sync is lost, regained for less than 5 minutes, then lost again. Such a condition may exist when GNSS jamming is present, or in the case of a poor antenna installation.

Please note, when entering holdover after a period of intermittent sync the holdover period timer is reset. This may cause the clock to enter into an extended holdover period, if the sync switching condition continues to be present. By disabling persistent holdover, you can ensure that the time in holdover is not extended by periods of intermittent sync lasting less than 5 minutes.
