PRPTP Firmware Release Notes

VERSION 3.15r8

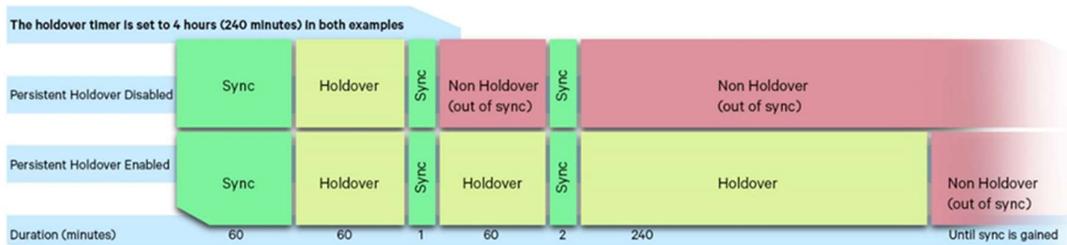
Normally, the clock can only enter holdover if it has been in sync for at least 5 minutes. If persistent holdover is enabled, and the clock has initially been in sync for at least 5 minutes, then the clock can still enter holdover if it experiences a sync switching condition. For example, sync is lost, regained for less than 5 minutes, then lost again. Such a condition may exist when GNSS jamming is present, or in the case of a poor antenna installation.

Please note, when entering holdover after a period of intermittent sync the holdover period timer is reset. This may cause the clock to enter an extended holdover period, if the sync switching condition continues to be present. By disabling persistent holdover, you can ensure that the time in holdover is not extended by periods of intermittent sync lasting less than 5 minutes.
