PRPTP Firmware Release Notes

VERSION 3.15r6

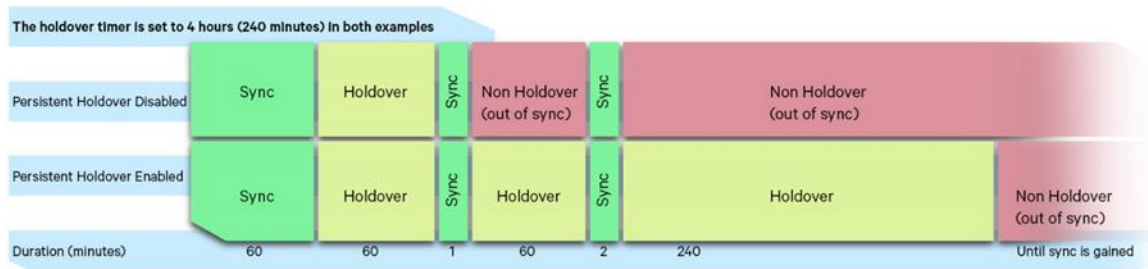
Normally, the clock can only enter holdover if it has been in sync for at least 5 minutes. If persistent holdover is enabled, and the clock has initially been in sync for at least 5 minutes, then the clock can still enter holdover if it experiences a sync switching condition. For example, sync is lost, regained for less than 5 minutes, then lost again. Such a condition may exist when GNSS jamming is present, or in the case of a poor antenna installation.

Please note, when entering holdover after a period of intermittent sync the holdover period timer is reset. This may cause the clock to enter an extended holdover period, if the sync switching condition continues to be present. By disabling persistent holdover, you can ensure that the time in holdover is not extended by periods of intermittent sync lasting less than 5 minutes.
